Archaeology of the St. Nicholas Church in demolished village of Libkovice (Liquitz) – excavations in 1995–1996 (North Bohemian Brown Coal Mining Area): a contribution to the research of medieval village churches in Bohemia

Archaeologia historica. 2020, vol. 45, iss. 1, pp. 185-20

ARCHAEOLOGY OF THE ST. NICHOLAS CHURCH IN DEMOLISHED VILLAGE OF LIBKOVICE (LIQUITZ) – EXCAVATIONS IN 1995–1996 (NORTH BOHEMIAN BROWN COAL MINING AREA). A CONTRIBUTION TO THE RESEARCH OF MEDIEVAL VILLAGE CHURCHES IN BOHEMIA

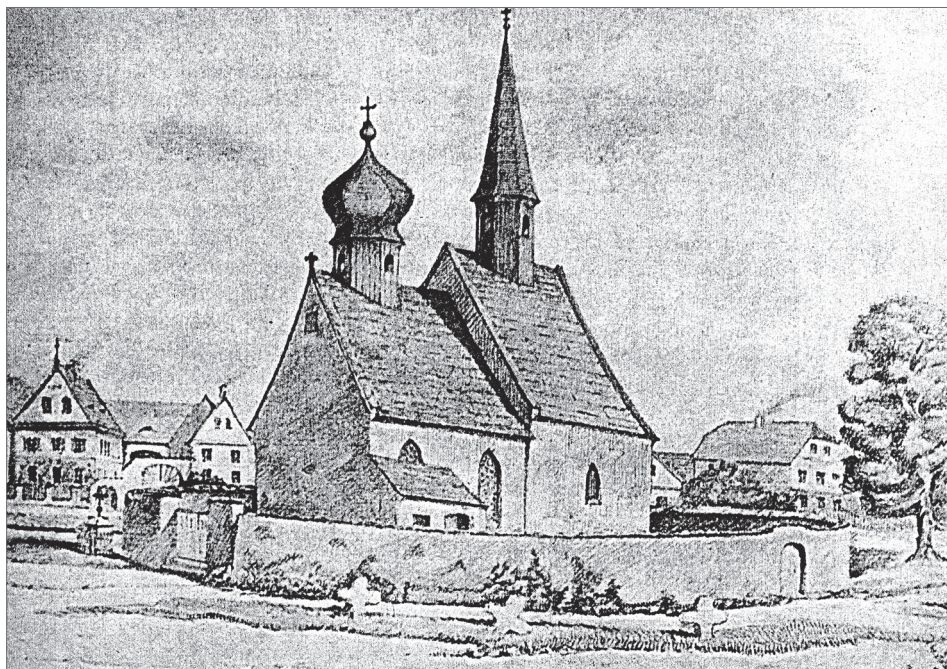
Fig. 2. Late 19th century drawing of the Gothic St. Nicholas church in Libkovice. After Vařeka 1996.

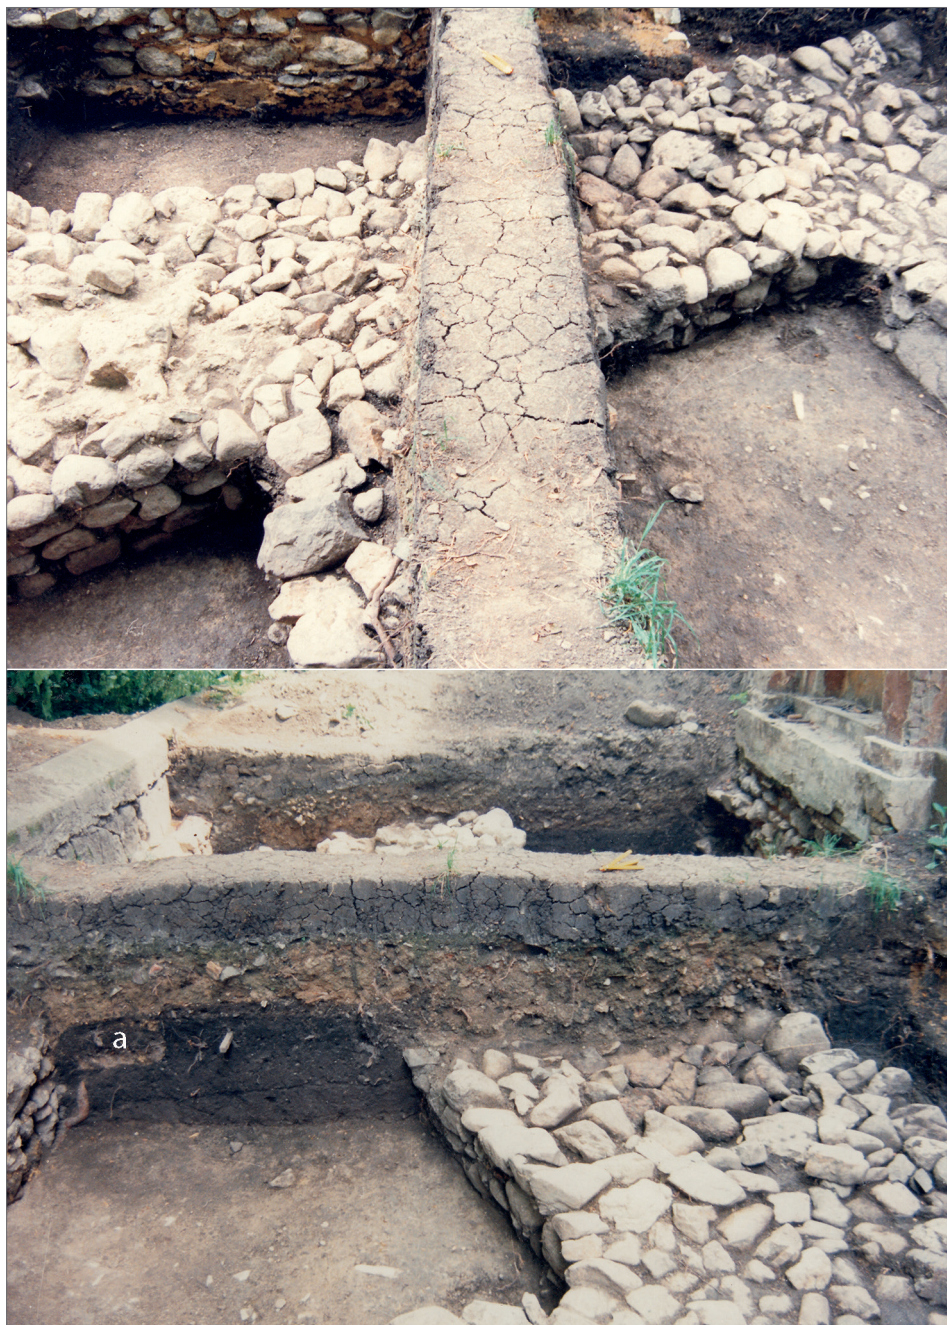
Fig. 6:1. Libkovice – St. Nicolas church. Intervention 95: foundation of the Gothic church – view from the North. Photo by P. Vařeka.

Fig. 6:2. Libkovice – St. Nicolas church. Intervention 95: foundation of the Gothic church and profile G–E. a – probable foundation trench of the earliest timber church. Photo by P. Vařeka.
